Manhole Inspection Summary

Manhole # S45M__019MH

Insp Date: **6/6/08 9:16 AM**

Location Address: **1716 thames st**

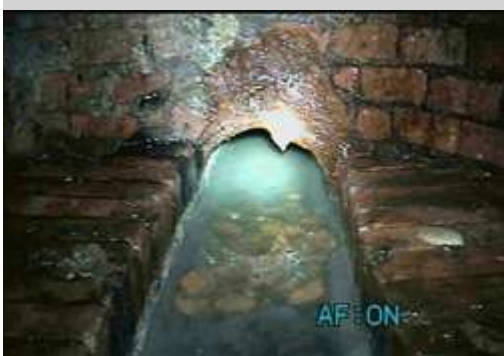
Defect 2

Infiltration: ☐ None ☐ Joint ☐ Cracks ☐ Mortar ☐ Roots ☒ **Wall**

Barrel Infiltration above 12 oclock pipe connection

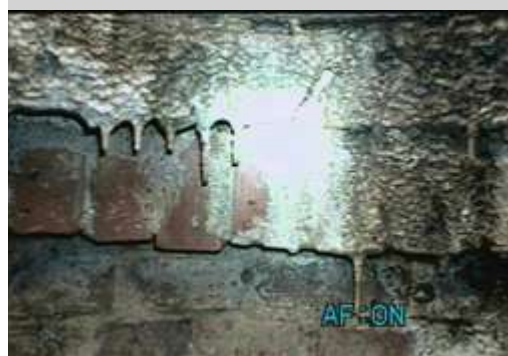
Defect 1

Condition: ☐ Sound ☒ **Cracked** ☐ Root Intrusion ☐ Loose Brick ☐ Deteriorated

Frame adj; cracked corbel

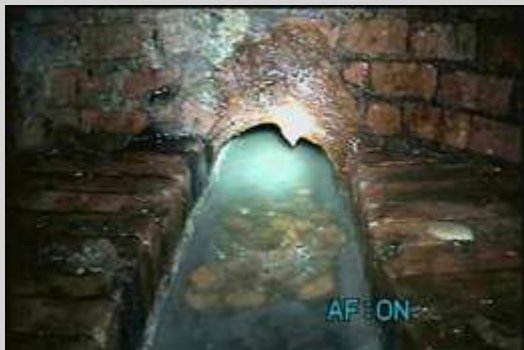
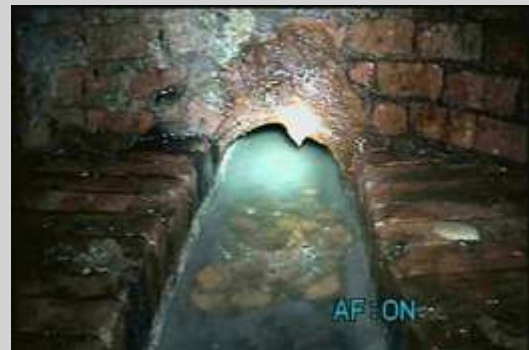
Defect 2

Barrel Infiltration above 12 oclock pipe connection
